United States Department of the Interior National Park Service
NATIONAL REGISTER OF HISTORIC PLACES REGISTRATION FORM

historic name: Rose Hill Farm

other name/site number: James-Marshall-Snyder Farm

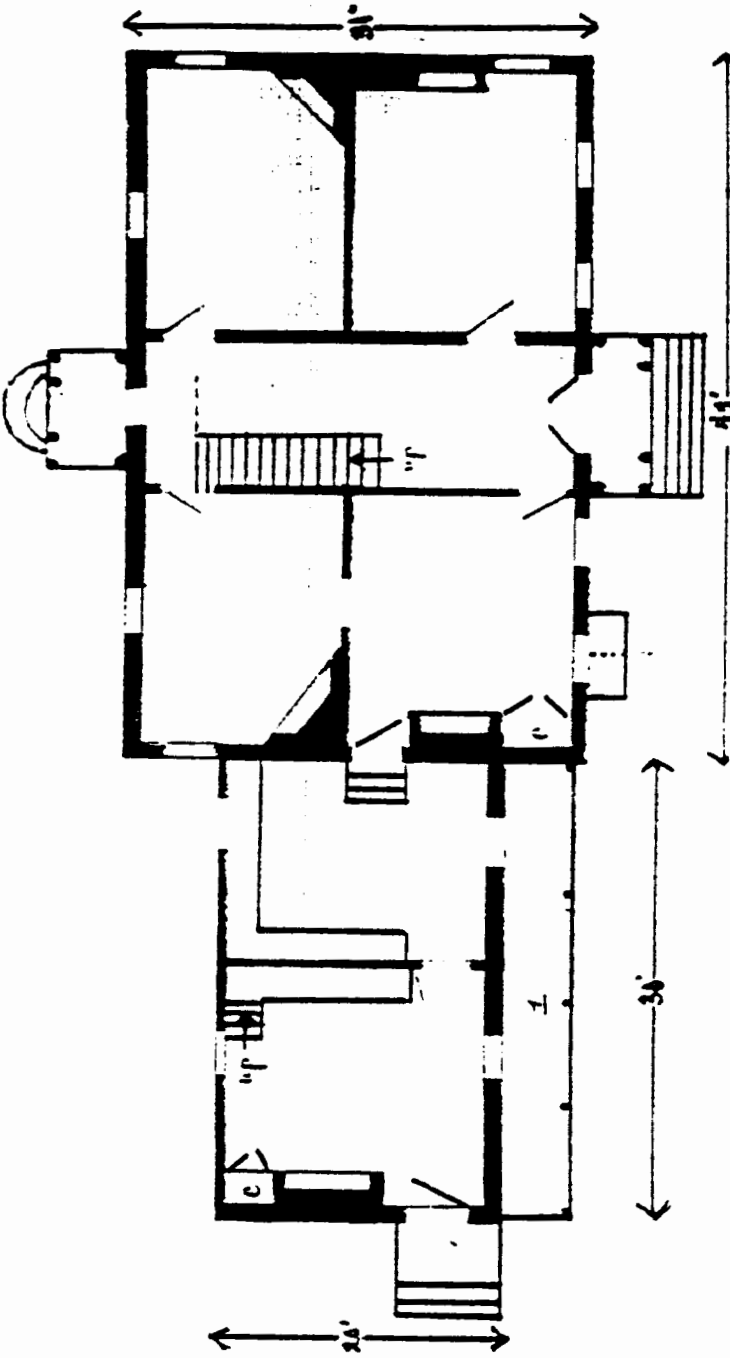
FIRST FLOOR

All the rooms and hallways in the center block, from the basement to the second floor, are in alignment including the fireplaces. The entrance hall at the east (front) entrance leads through to the west entrance. The stairway begins at the east end and has walnut handrails and poplar newel posts. The 1st floor tapered newel post is crowned with a flat cap over a pineapple-topped post. The handrail leading to the 2nd floor (at the landing) passes over an acorn shaped cap on a tapered newel post. The stair risers are marbled which is original with the house and continues to the attic. The open string side of the staircase has scrolled brackets. The hall baseboard with a beaded edge is also marbled.

The living room and dining room on either side of the center hall have fireplaces on the wall opposite the door into the rooms. The living room fireplace surround is wood with supporting columns. The dining room has a simple painted wood mantel. A two-tiered raised paneled cupboard is at the left of the fireplace and fills the wall between it and the east wall. The door and window wood trim in both rooms is made to look like pilasters with corner blocks. The beaded baseboards are marbled in the living room only. The 2 rooms flanking the west entrance are smaller with corner fireplaces - not in use - and simple flat boards for door and window framing. The baseboards are painted. The floors are yellow pine, random width throughout the house. A single paneled door to the basement is under the staircase and faces the back or west entrance.

The kitchen is in the wing, a later addition, and is reached from the dining room by going down 3 steps. It has a door to the porch on the east side. The second room in the wing is a family room with a door to the outside and large fireplace for cooking on the south wall. A stairway to the 2nd floor is between the kitchen and the family room; a bath is under the staircase. The wing has 2 rooms on each floor and no

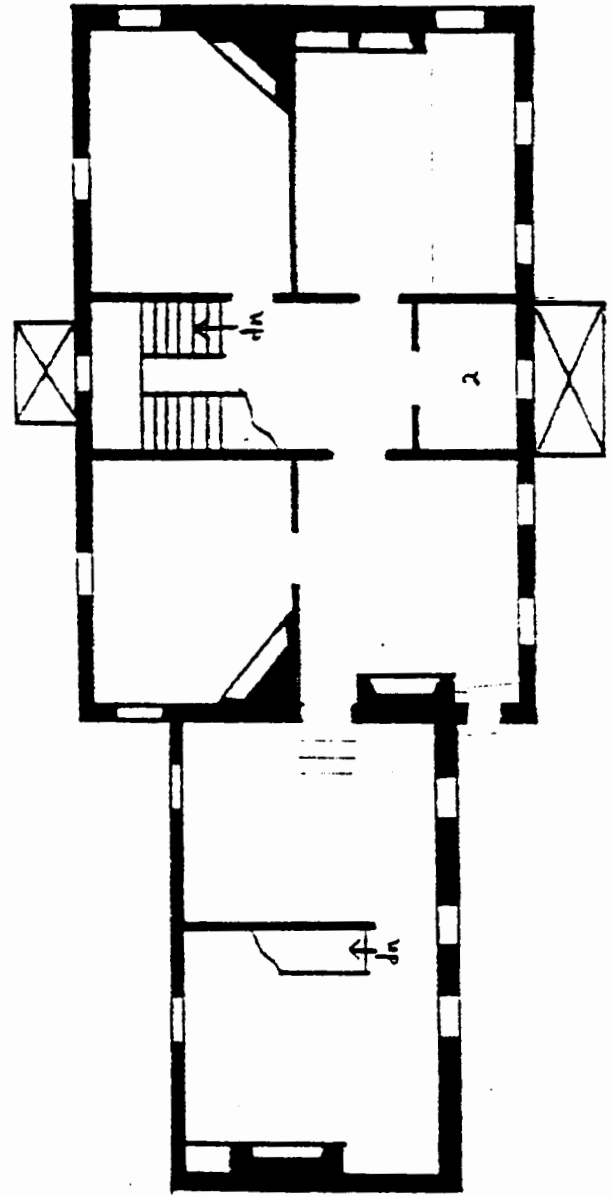
SECOND FLOOR

The second floor rooms have the same floor plan but the wood trim is less ornate. However, the fireplace in the larger north bedroom is marbled as were all the other fireplaces originally. A bathroom was installed in the east end of the hall.
