HISTORIC PROPERTIES INVENTORY FORM

1. NAME(S), historic/common: Parkersburg Woman's Club
2. LOCATION, street/road: 323 Ninth St.
TAX MAP - LOT # 80-113
city/town: Parkersburg, WV 26101
(incorporated/unincorporated)
3. USE/FUNCTION, present: women's club
original: residential
4. OWNER/ADDRESS, present: Parkersburg Woman's Club
address above
original:
5. PHOTO/SKETCH OF: 8112-R3-F4-5
8201-R2-F12-13
7. PLAN (include approx. dimensions):

Parkersburg Women's Club
323 Ninth St.
80-113

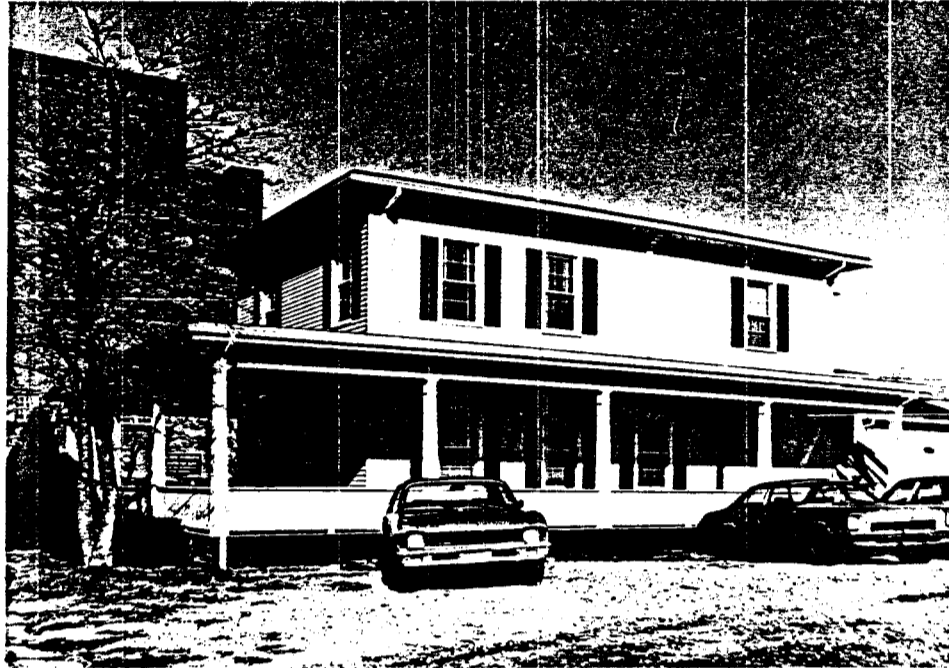
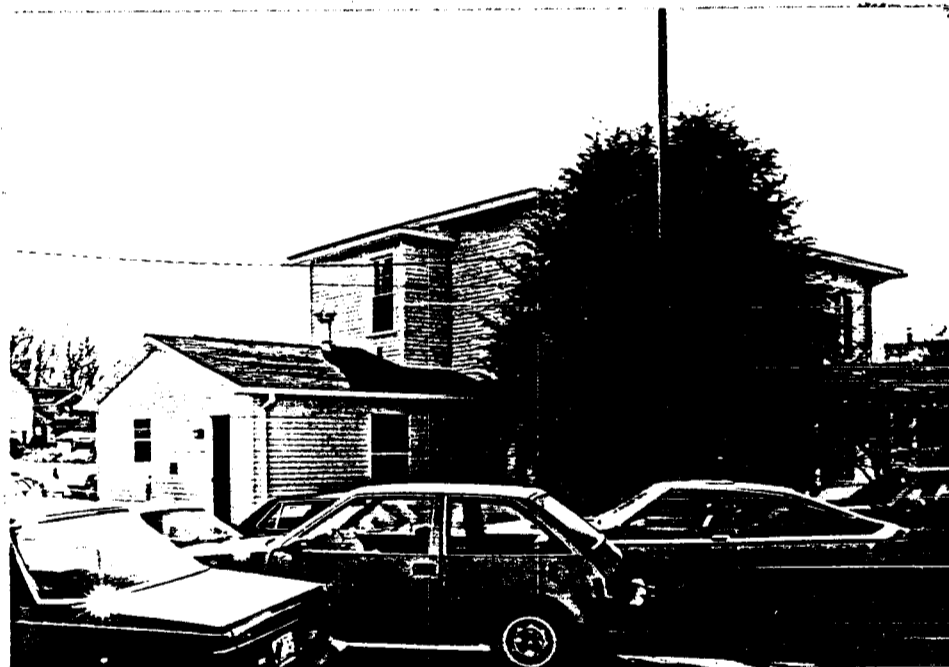
Sited on a large open lot, this altered two story house has a very low hip roof with brackets and an irregular bay system of approximately two by four bays. Its d/s (6/6) windows have narrow architrave trim and inoperative shutters. A one story porch on square posts with a solid balustrade runs around the SE, SW, and NW sides. A one story gable roofed addition extends to the NE.
