HISTORIC PROPERTIES INVENTORY FORM

1. NAME(S), historic/common: Union Trust & Deposit Co. /  
Union Trust National Bank
2. LOCATION, street/road: 700 Market St.  
TAX MAP- LOT #  
91-4 city/town: Parkersburg, WV 26101  
(incorporated/unincorporated)
3. USE/FUNCTION, present: bank

Union Trust & Deposit Co. / Union Trust National Bank  
700 Market St.  
91-4

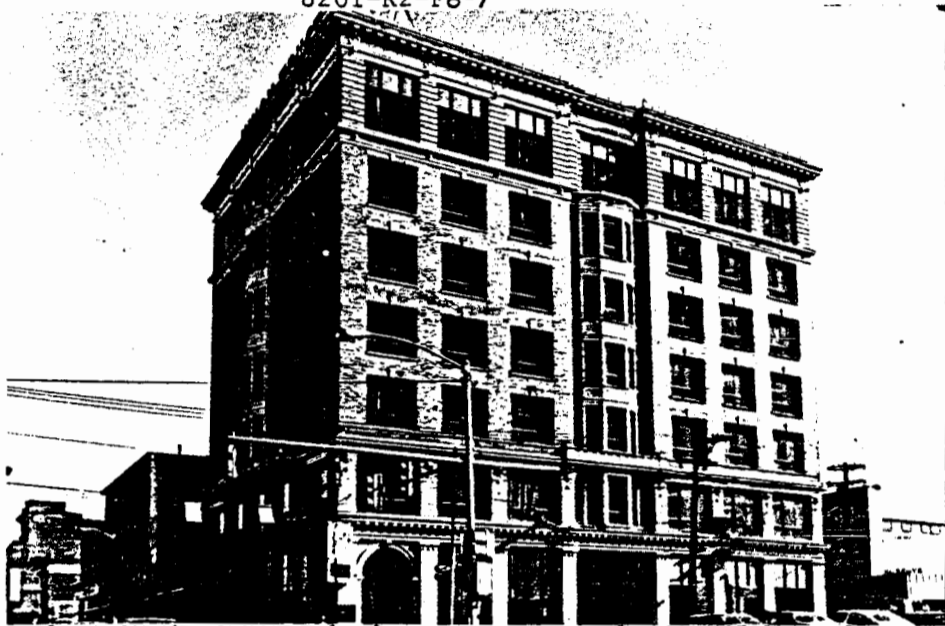
96 X 120

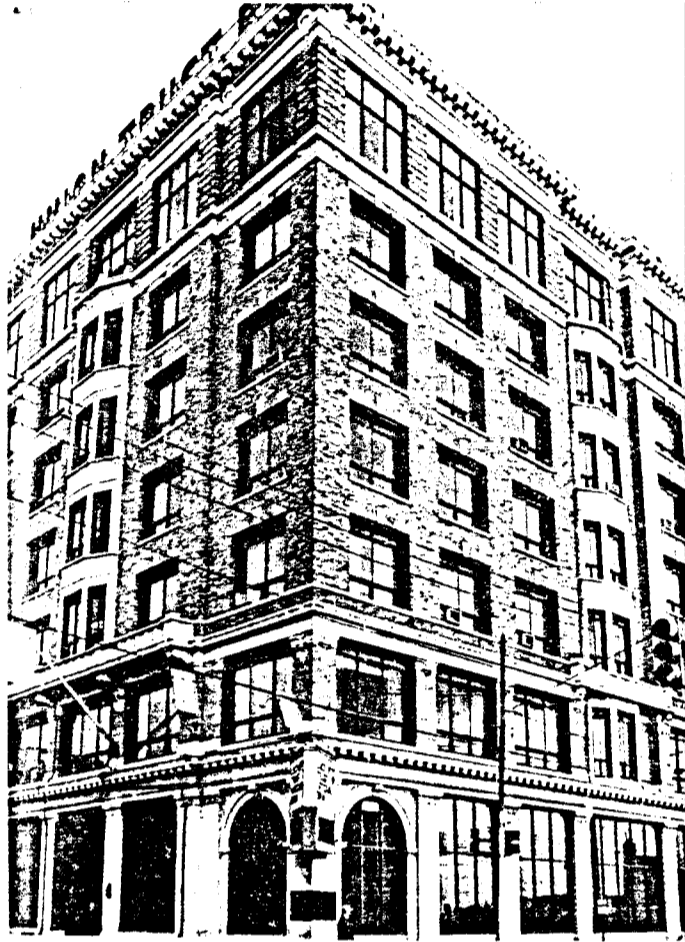
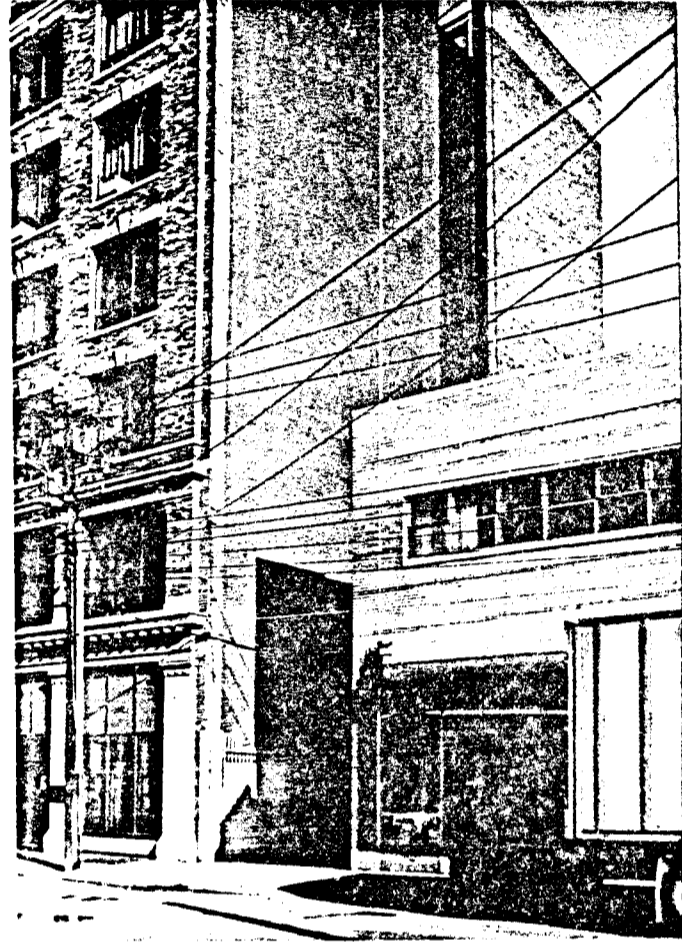
This is a solidly constructed 7 story, 5 by 7 bay building in a U-shape with the Classical columnar design of base, shaft, and capital. The base is a smooth dressed stone pilaster and window system with corner arches and a modillion cornice; the capital is a metal modillion and dentiled cornice with cartouches below and acroterions above. The shaft consists of wide window apertures with brick relieving arches and stone keystones and sills, containing replacement windows. The central bay (NW) is a projecting 3 sided bay. Above the 2nd story, whose window apertures are larger, is a balconet on consoles. The 1st story apertures, also with replacement windows, are arched at the corners. On the 2 less exposed facades (SE & NE) the fenestration is a simple system of paired d/s (1/1) with stone lintels and sills.
